# Ompompanoosuc Watershed Phase I Geomorphic Assessment

Orange and Windsor Counties, Vermont

**April 16, 2009**

Prepared by: **Bear Creek Environmental, LLC**

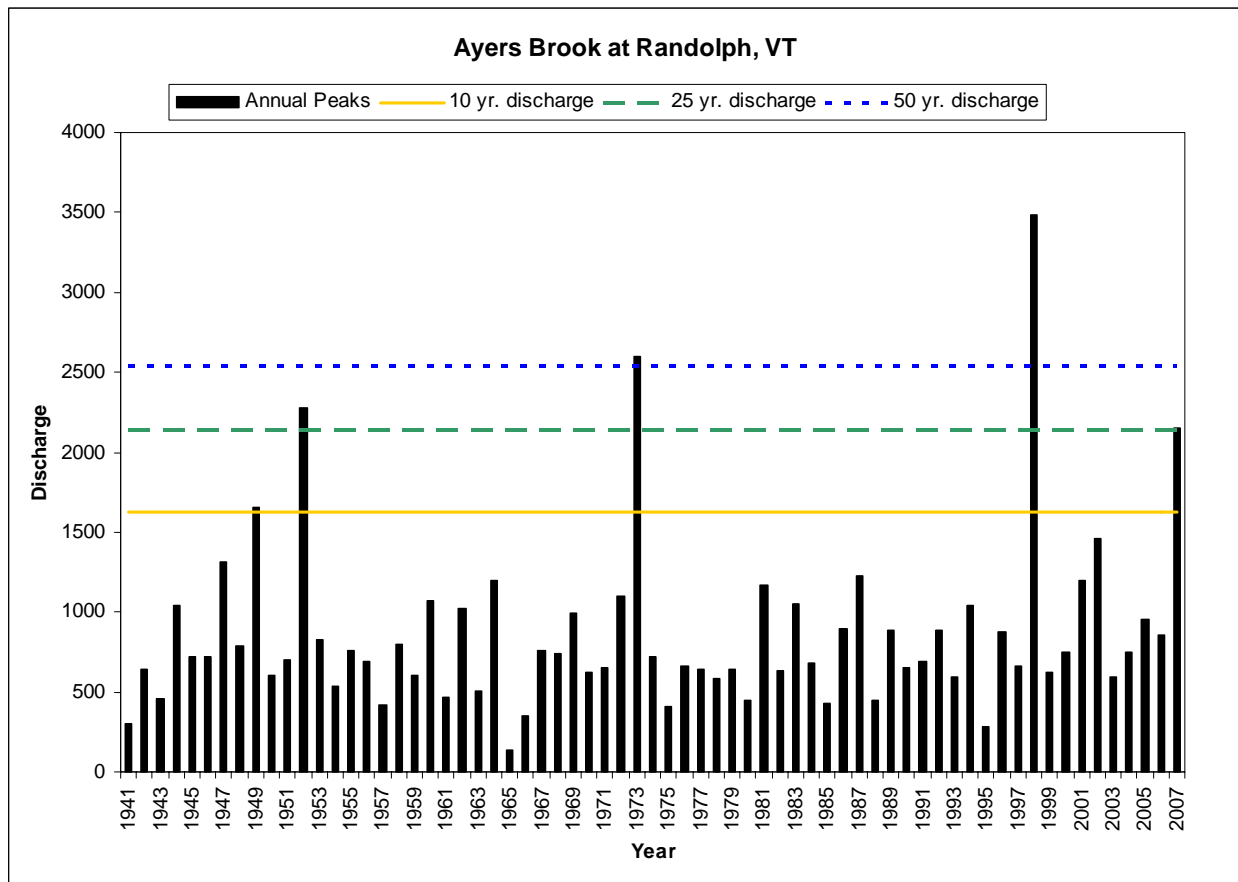
**Figure 3: Flood frequency analysis for Ayers Brook**

1949 and 2007 as shown below in Figure 3. The annual peak discharge was between the 25 and 50 year recurrence interval in 1952 and exceeded the 50 year recurrence interval in 1973 and 1998. These USGS peak discharge flow values for each year do not account for the effects of flow regulations and diversions.

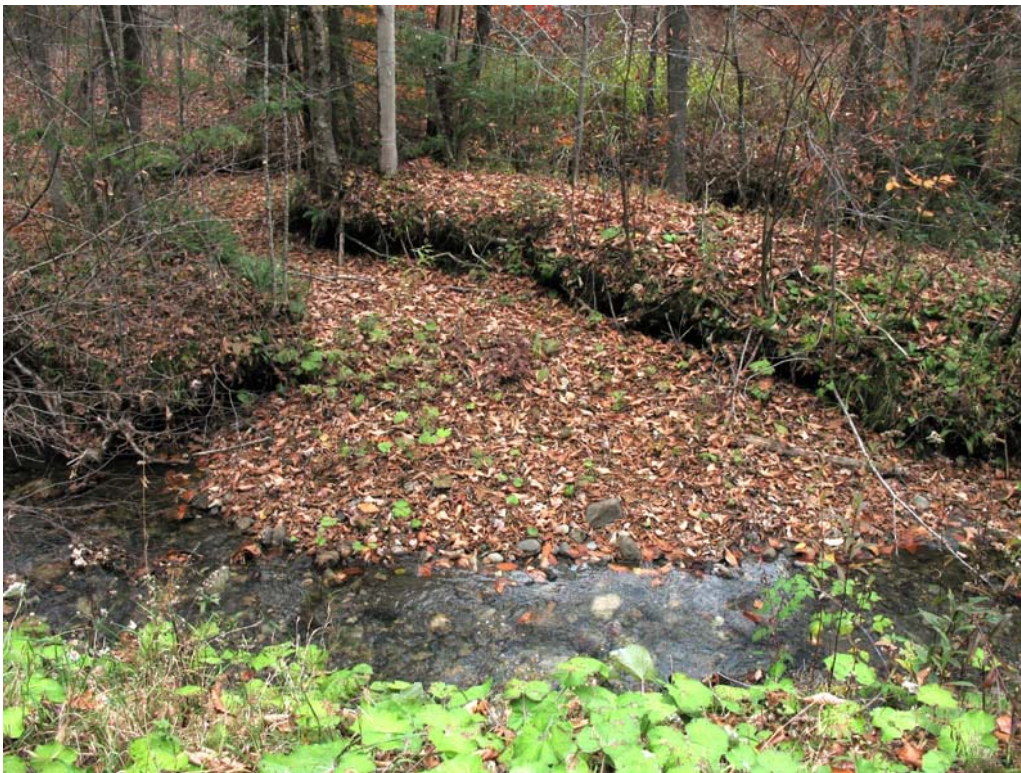
Nine reaches in this watershed received an impact rating of high (frequent occurrences) due to evidence of frequent channel migration, avulsion, and neck cutoffs (Figure 7). These reaches are located on the West Branch of the Ompompanoosuc, the main stem of the Ompompanoosuc, Middle Brook, and Blood Brook. On the main stem Ompompanoosuc, high impact reaches are upstream of the confluence with the West Branch (R08, R11, R17, and R28). Reaches in the lower section of Blood Brook (near the Lake Fairlee inlet) had high impact ratings for channel migration (R16T2.04 and R16T2.05). The most downstream reach on Middle Brook (R16T2.03S1.01) and the reach just upstream of the wetland area (R16T2.03S1.06) also had high impact ratings. This active movement of the stream channel is an indicator of significant channel adjustment. Thirteen reaches that showed few occurrences of channel migration, avulsion, and neck cutoffs were classified as having low impact from channel migration. These reaches are located on the main stem of the Ompompanoosuc, the West Branch of the Ompompanoosuc, Abbott Brook, Middle Brook, and Tributary three to the Ompompanoosuc River. The remaining four reaches, where meander migration was noted, were not significantly impacted. These reaches are located on the main stem of the Ompompanoosuc River, Barker Brook, and the Lake Fairlee outlet.

**Figure 7. Channel Avulsion on R18T3.07 (Tributary Three to Ompompanoosuc River)**

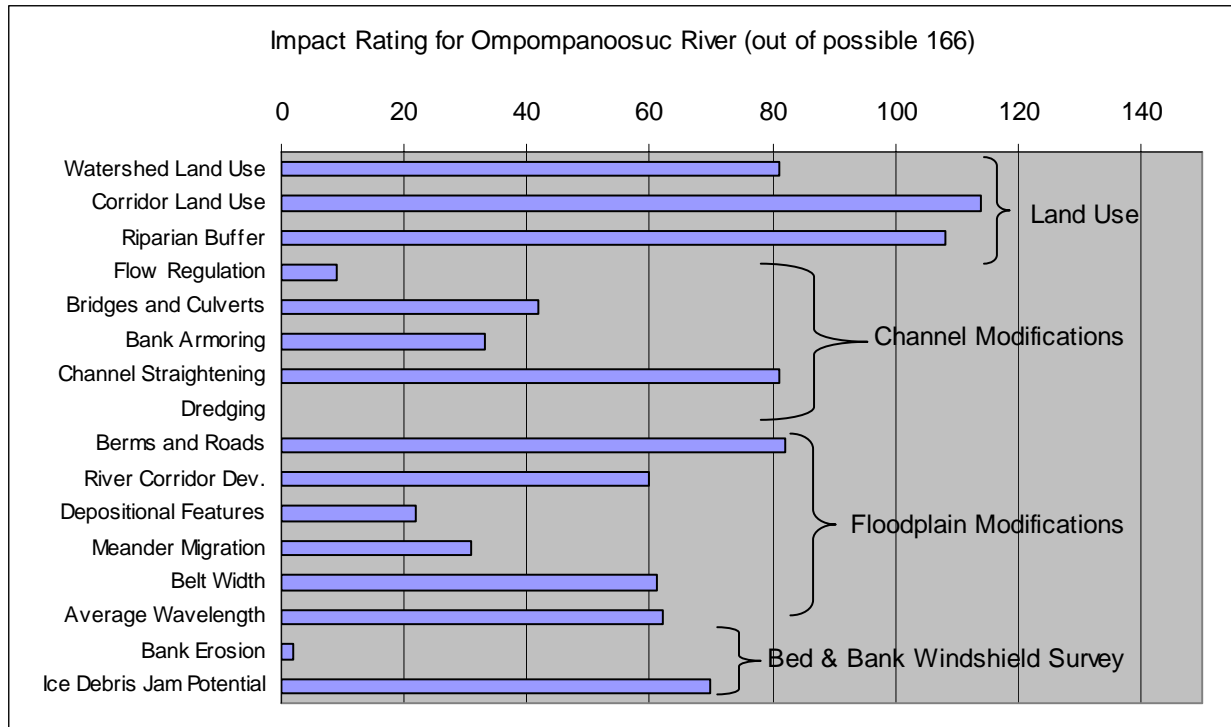
Figure 8: Impact Rating for Ompompanoosuc River Watershed by Parameter and Category

The impact scores for each Phase I step and total scores are reported on pages 25 through 27 of the Appendix. The Phase I Stream Geomorphic Assessment evaluates parameters that may cause channel adjustment. These parameters are grouped into four major categories: land use, in-stream modifications, floodplain modifications, and bed and bank windshield survey. Reach summary reports of these four categories are provided on pages 28 through 30 of the Appendix. Adjustment scores, reach condition, and reach sensitivity for all reaches are provided on pages 31 through 33 of the Appendix.

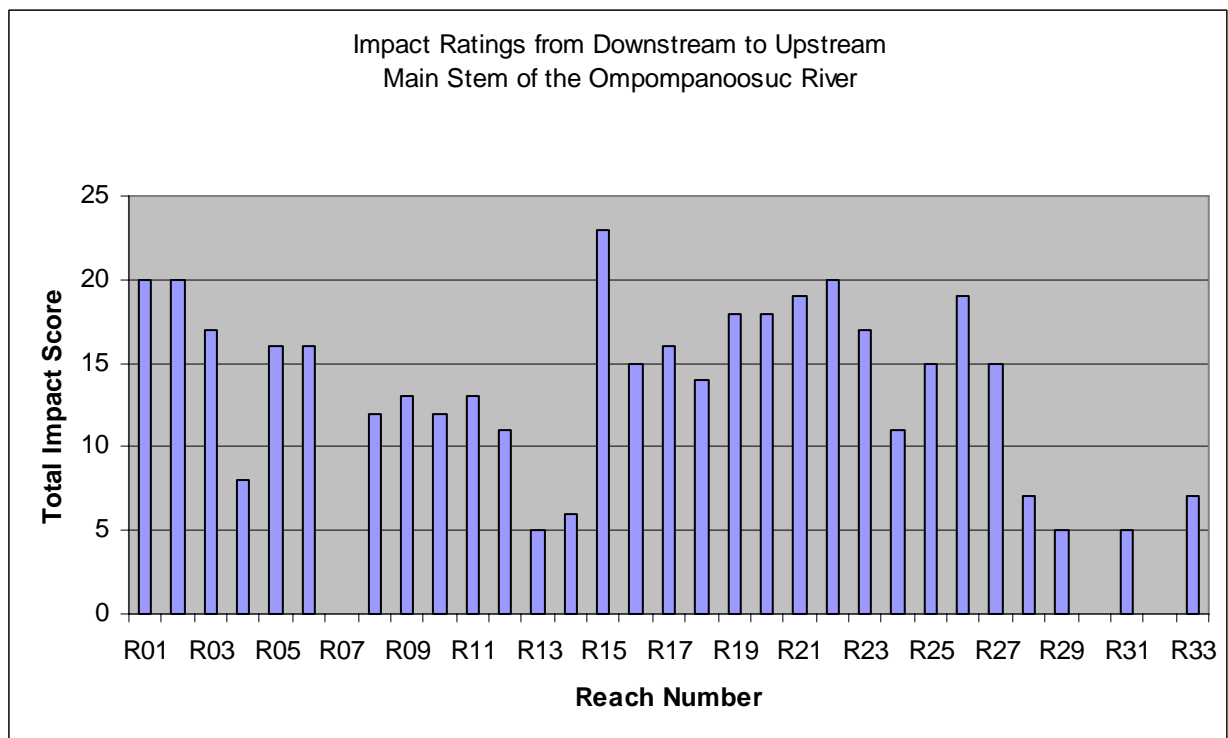
Figure 9: Impact Ratings (out of 32) from downstream to upstream on the main stem of the Ompompanoosuc River

The total impact scores (out of 32 possible) for the Phase I assessment for the main stem of the Ompompanoosuc River are summarized below in Figure 9. Reach R15 had the highest total impact rating of 23. This reach is downstream of a dam, has been straightened and armored considerably and is also impacted by the Route 113 Bridge, development and lack of buffer. In the Ompompanoosuc River Watershed, there were four reaches (R01, R02, R06, and R15) that received a Phase I reach condition of poor (Figure 10). These reaches are all located on the main stem of the Ompompanoosuc River. Three of the four reaches
